Application Note

SnapSAN ALUA in an ESXi Environment

This application note describes how Asymmetric Logical Unit Access (ALUA) functionality works in an ESXi environment with SnapSAN arrays and how to disable it.

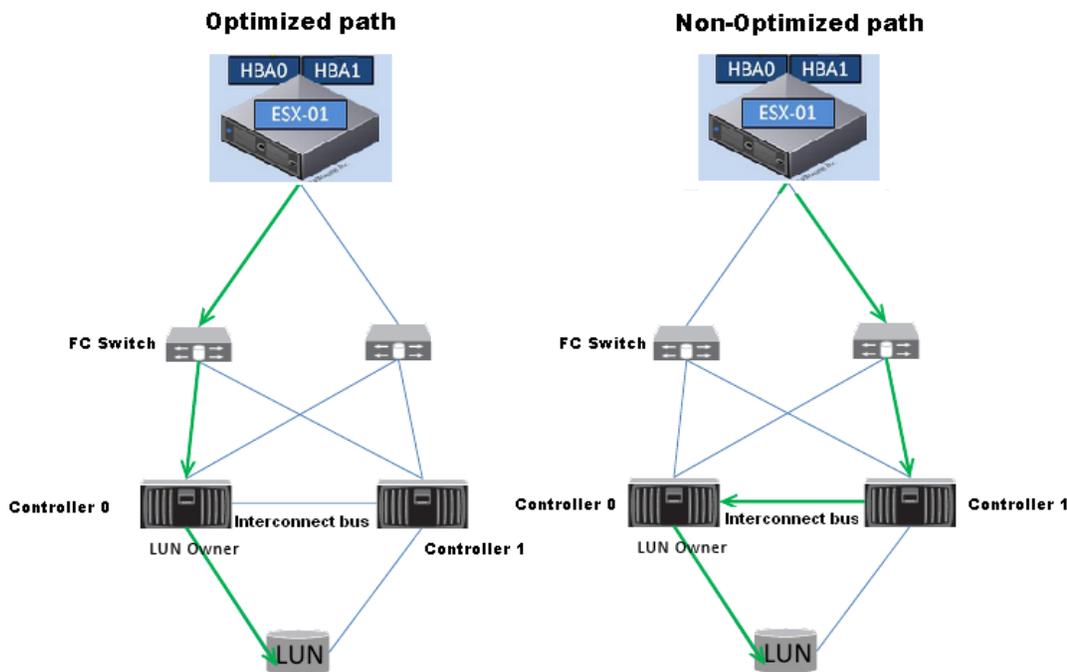
The following image depicts the ALUA configuration in an ESXi environment:

Asymmetric Logical Unit Access (ALUA) is a SCSI3 (SPC-3) standard that allows a storage device to signify to VMware ESXi host servers which paths are preferred. By default the SnapSAN ALUA is enabled, thus ESXi complies with this configuration.

The SnapSAN is ALUA compliant; this means the LUN is accessible through both storage processors (controllers) as **Active**, but only one of these storage processors actually “owns” the LUN.

- **Optimized Path (Active I/O)** - A direct path to the storage processor that owns the LUN.
- **Non-optimized Path (Active)** - A connection with the storage processor that owns the LUN through an interconnected bus.

VMware tracks information about the processor owning the LUNs and prefers sending traffic directly to the owner in the optimized path. The Most Recently Used (MRU) pathing policy takes optimized / non-optimized paths into account. When the optimized path is not available, MRU uses a non-optimized path. Once the optimized path is available, MRU switches back to the optimized path.

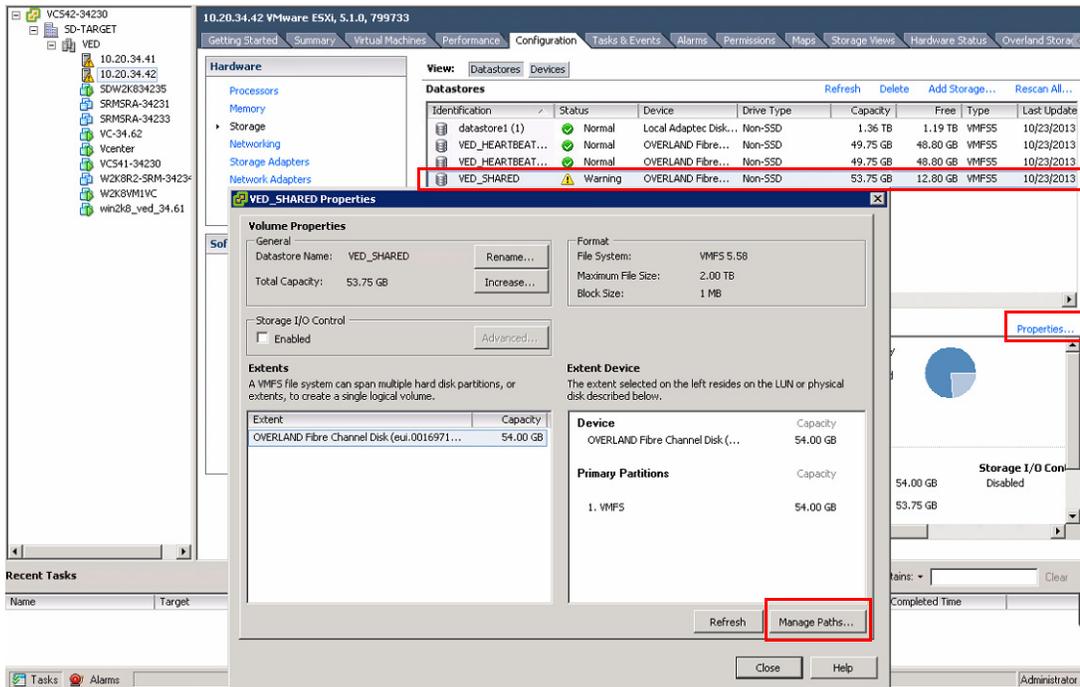
1. From the vSphere Client console, select the **host** from the left-pane.
2. Navigate to **Configuration > Storage** view.
3. From **Datastores** list, select the particular **datastore**.
4. Click the **Properties** link.
5. Click **Manage Paths**.

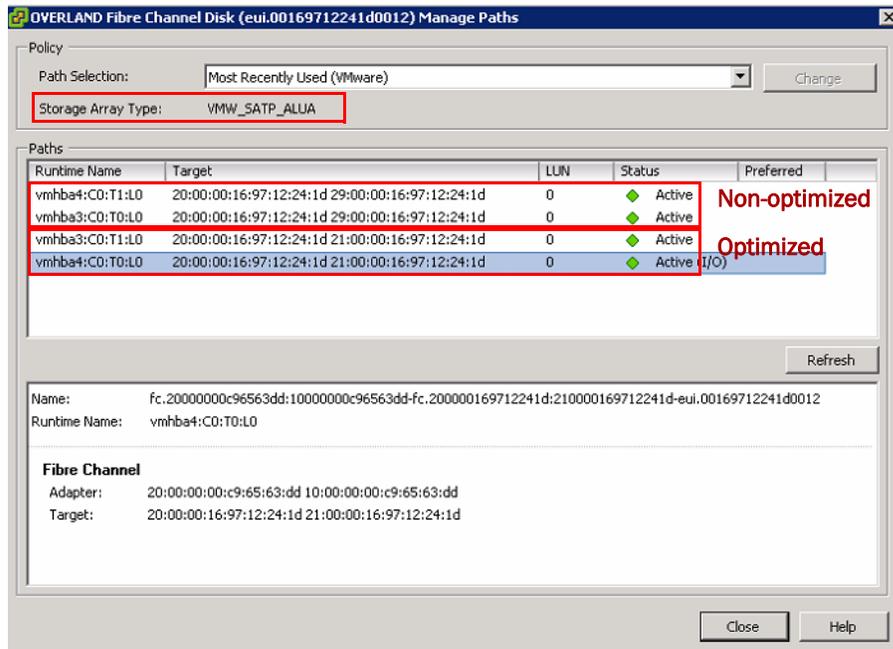
- The SnapSAN is ALUA aware thus the **Storage Array Type** by default is **VMW_SATP_ALUA** this is displayed in the following image along with the available paths:

- vmhba4:C0:T1:L0 and vmhba3:C0:T0:L0 are non-optimized paths.
- vmhba3:C0:T1:L0 and vmhba4:C0:T0:L0 are optimized paths.

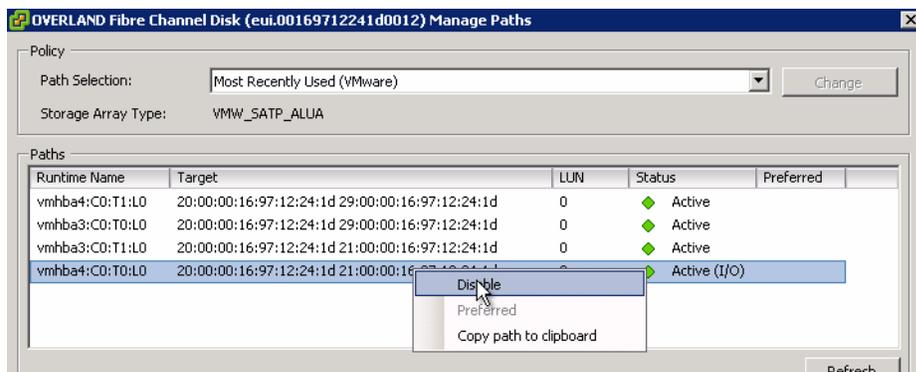
- Right-click the **path with Active (I/O)** and select **Disable**.

The following steps show how failover of the Active I/O takes place with ALUA. The examples provided show how Active I/O paths behave when the paths become unavailable (**Disabled**) and how SnapSAN works in an ESXi environment.

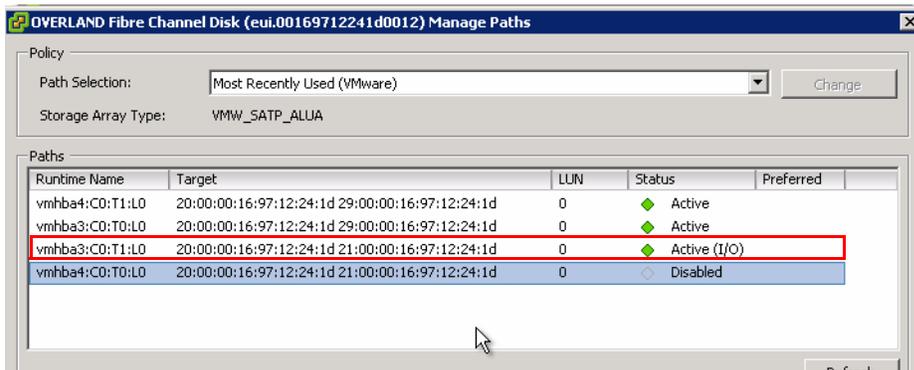
- The results after disabling the default path show that the second optimized path is now the primary with a status of **Active I/O**.

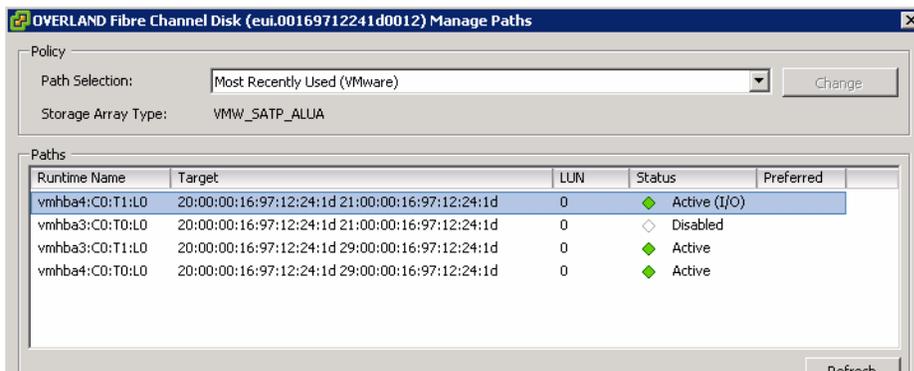
- Repeat [Step 1](#) to disable the **other optimized path**. This assigns the **Active (I/O)** to a non-optimized path:

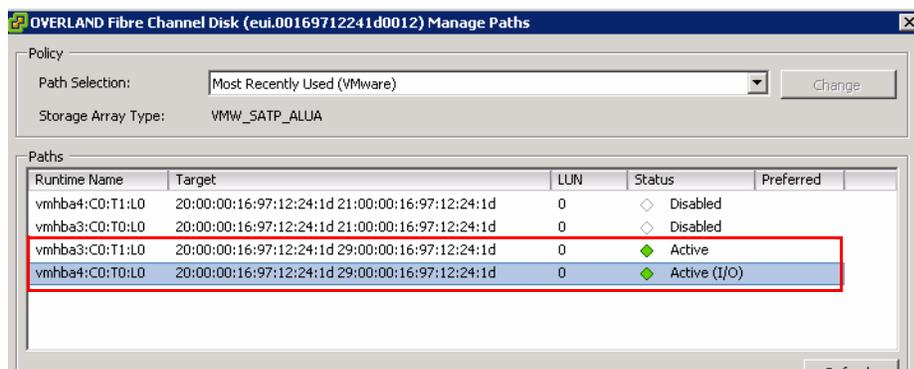
- Right-click on the **optimized path** and select **Activate**. Immediately after the enable action, the **Active (I/O)** switches back to one of the optimized paths from a non-optimized path.

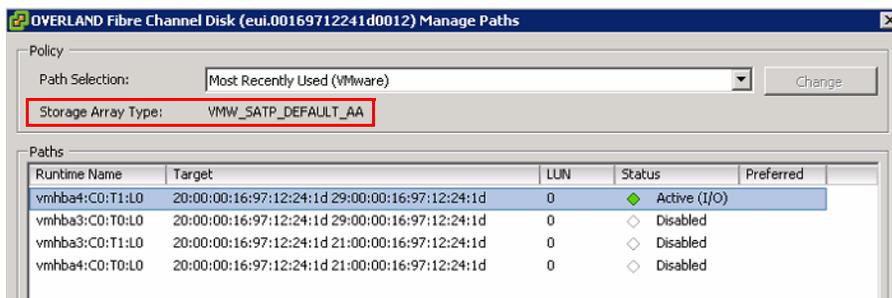
NOTE: The **Storage Array Type** is now **VMW_SATP_DEFAULT_AA**. For test purposes, we have disabled all the optimized paths.

6. The **Active (I/O)** now switches to a non-optimized path.

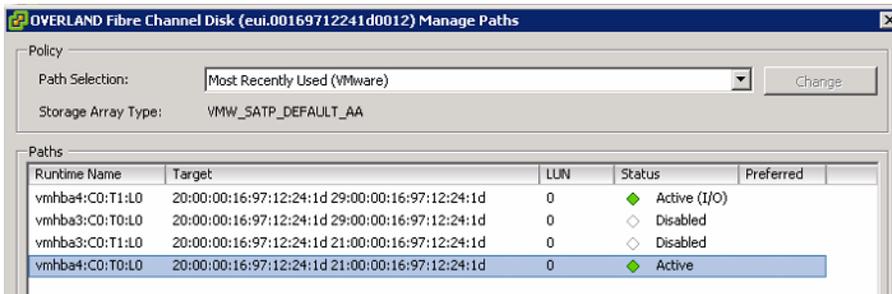
7. Enable one of the original **optimized paths** and confirm that **Active (I/O)** does not switch back to the optimized path.

This is because ALUA has been disabled on the SnapSAN. In some cases disabling ALUA on the SnapSAN may be beneficial.
